STORMWATER MANAGEMENT FACILITY OPERATIONS & MAINTENANCE MANUAL

ER/UDC WEST WINDSOR LLC

Township of West Windsor
Mercer County, New Jersey

Stormwater Management Measures Maintenance Plan & Field Manuals

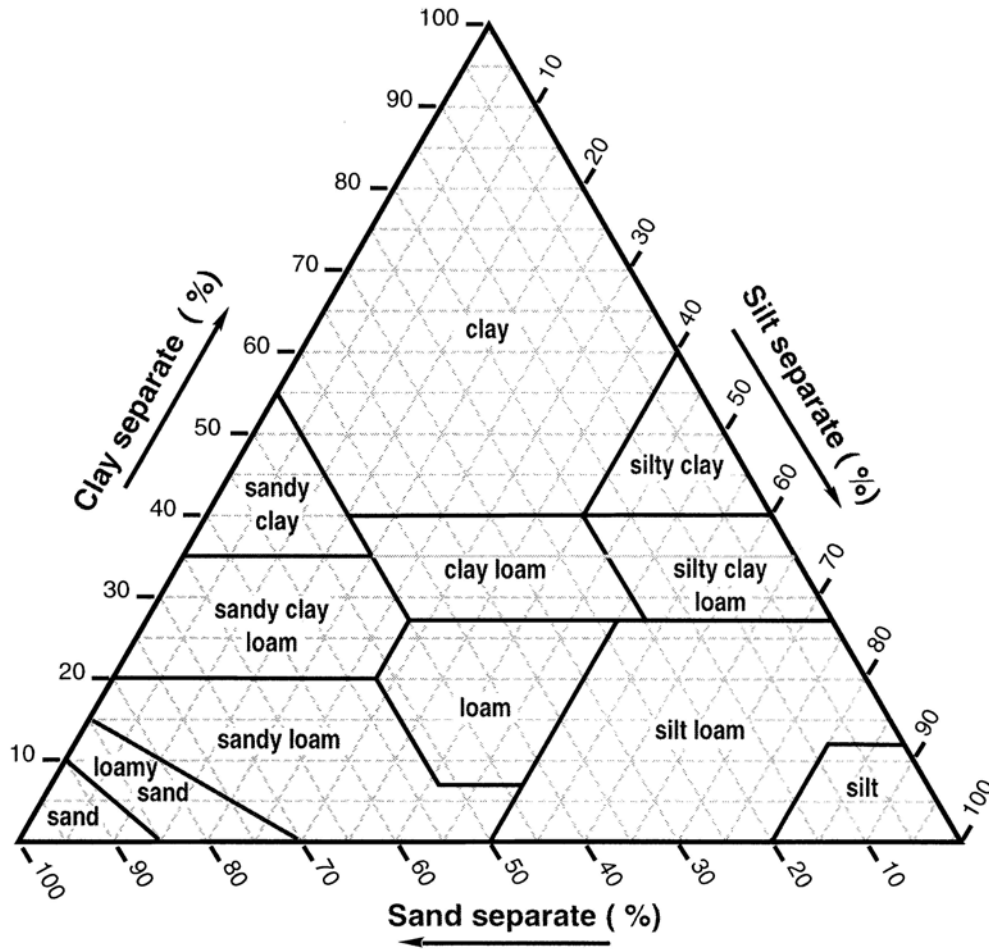
Texture Triangle:

Fine Earth Texture Classes (———)

USDA SOIL CLASSIFICATION SYSTEM

Detailed descriptions of the encountered subsurface conditions are described on the Test Pit Logs, Plates 3-1 through 3-28, and Test Boring Logs, Plates 4-1 and 4-2. The soils were visually classified in general accordance with the procedures of the United States Department of Agriculture Soil Classification System (USDA) described on Plate 5.

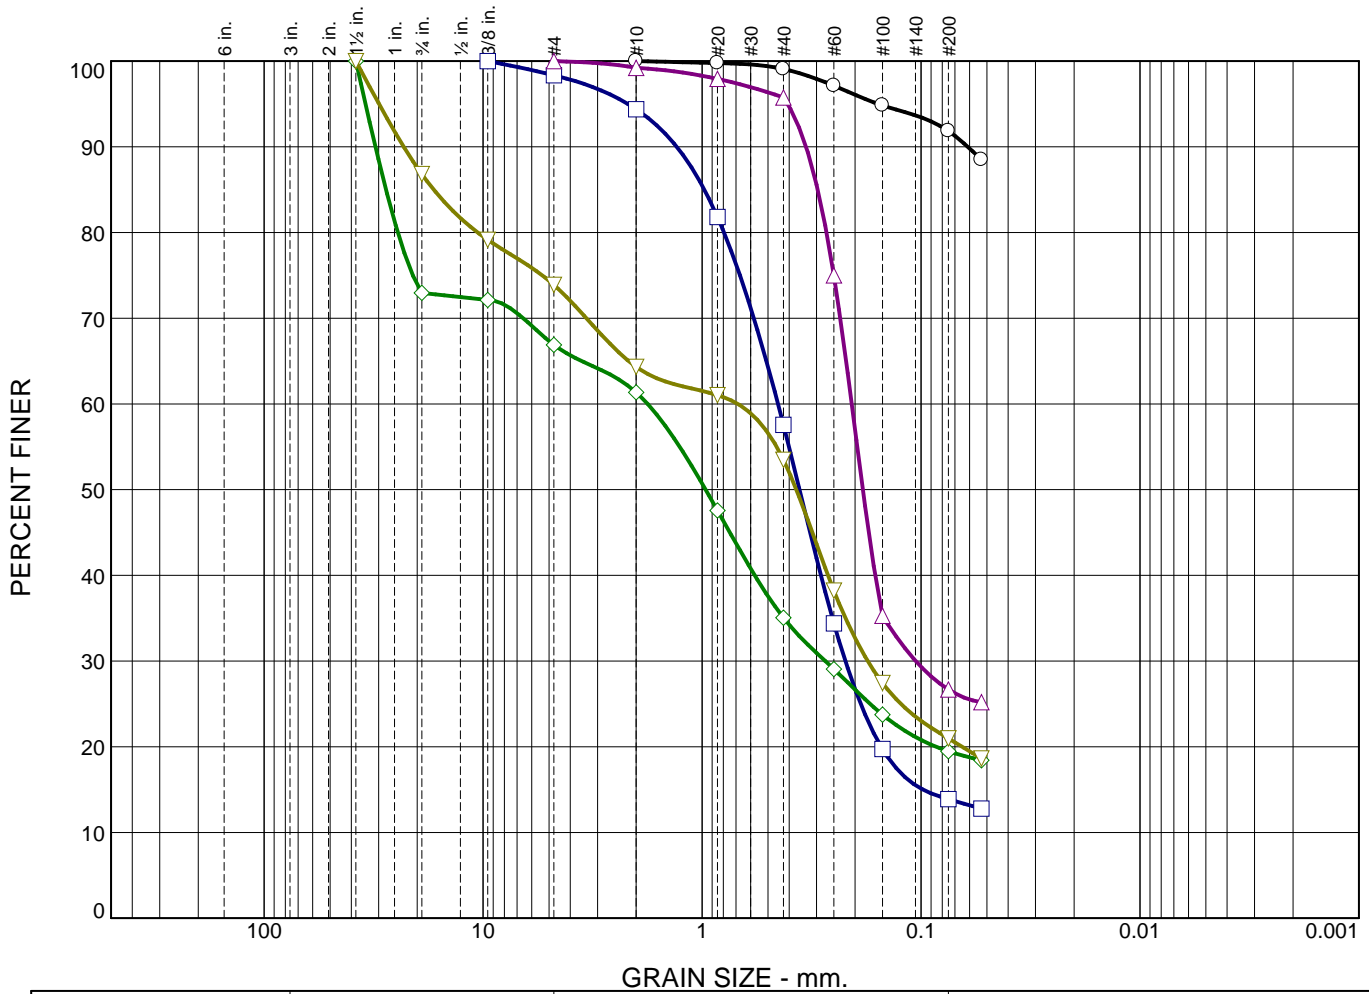
Gradation Curve(s)

% Cobbles	% Gravel		% Sand			% Fines	
		Coarse	Fine	Coarse	Medium	Fine	Silt	Clay
○	0.0	0.0	0.0	0.0	0.9	7.3	91.8	
□	0.0	0.0	1.7	3.9	36.8	43.7	13.9	
△	0.0	0.0	0.0	0.8	3.4	69.1	26.7	
◇	0.0	27.0	6.1	5.6	26.2	15.6	19.5	
▽	0.0	13.2	12.9	9.6	10.8	32.5	21.0

SOIL DATA					
SYMBOL	SOURCE	SAMPLE NO.	DEPTH (ft.)	Material Description	USCS
○	B-1	1	1.5	Silty Clay (MC=26.0%)	CL
□	B-2	3	8	Loamy Sand (MC=12.5%)	SM
△	TP-4	4	9	Sandy Loam (MC=16.6%)	SM
◇	TP-7	2	4	Sandy Loam (MC=8.8%)	SM
▽	TP-12	2	7.5	Sandy Loam (MC=9.3%)	SM

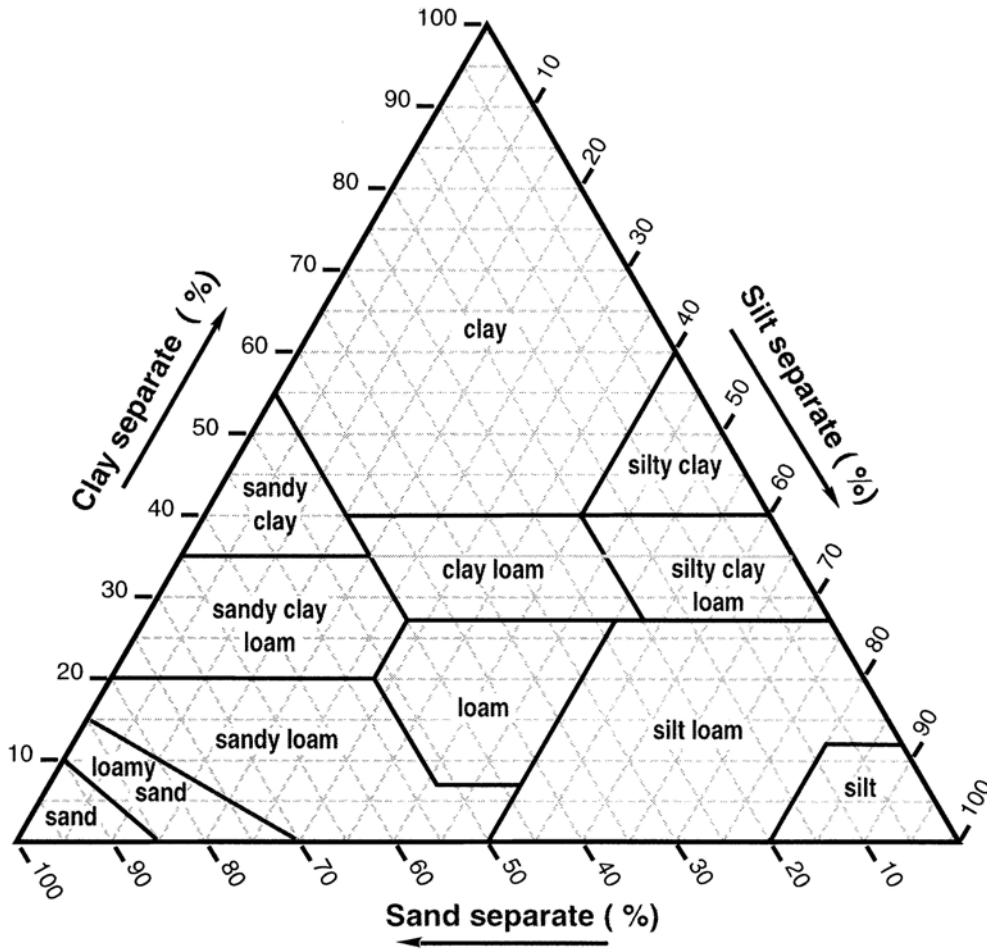
Texture Triangle:

Fine Earth Texture Classes (———)

USDA SOIL CLASSIFICATION SYSTEM

Detailed descriptions of the encountered subsurface conditions are presented on the Test Pit Logs, Plates 3A through 3D. The soils observed during the test pit excavations were visually classified in general accordance with the procedures of the United States Department of Agriculture Soil Classification System (USDA) described on Plate 4.

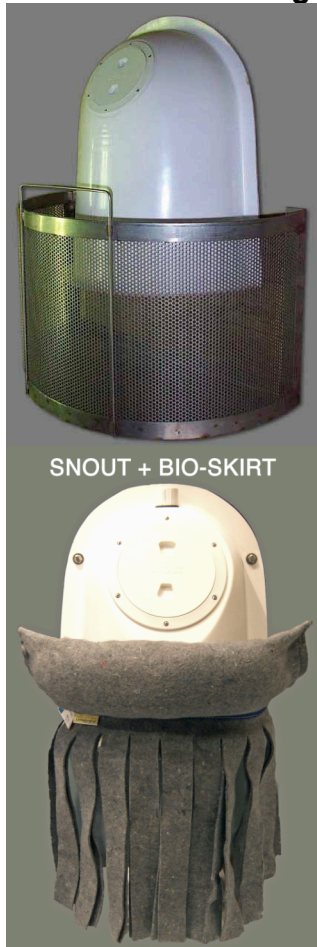
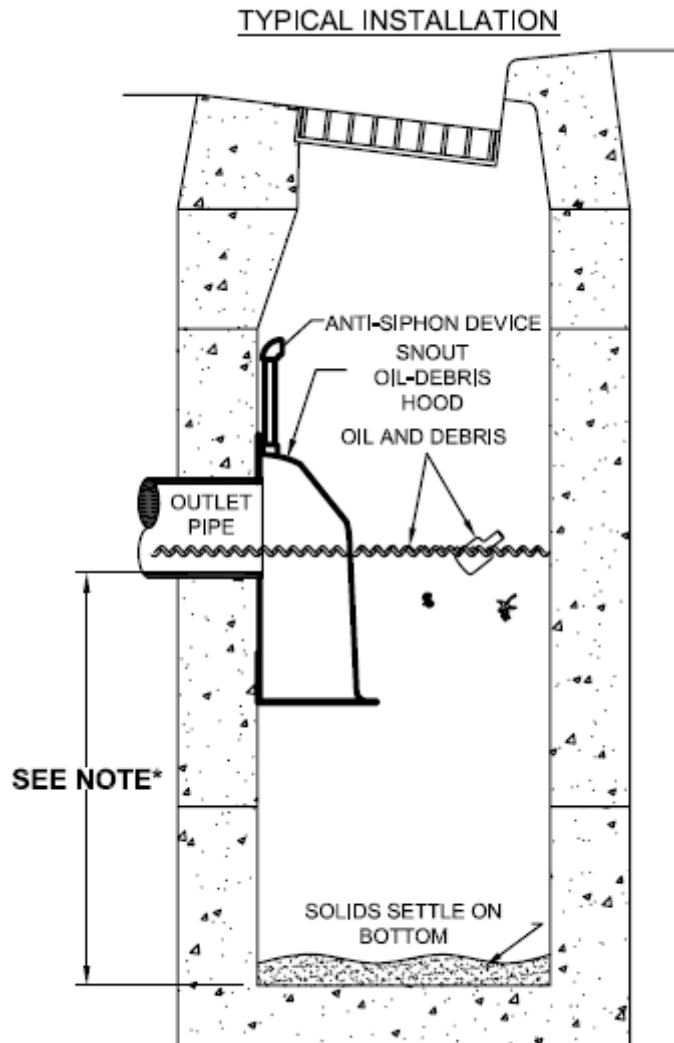
Installation Drawing:

*NOTE- SUMP DEPTH OF 36" MIN. FOR $\leq 12"$ DIAM. OUTLET. FOR OUTLETS $\geq 15"$, DEPTH = 2.5-3X DIAM.

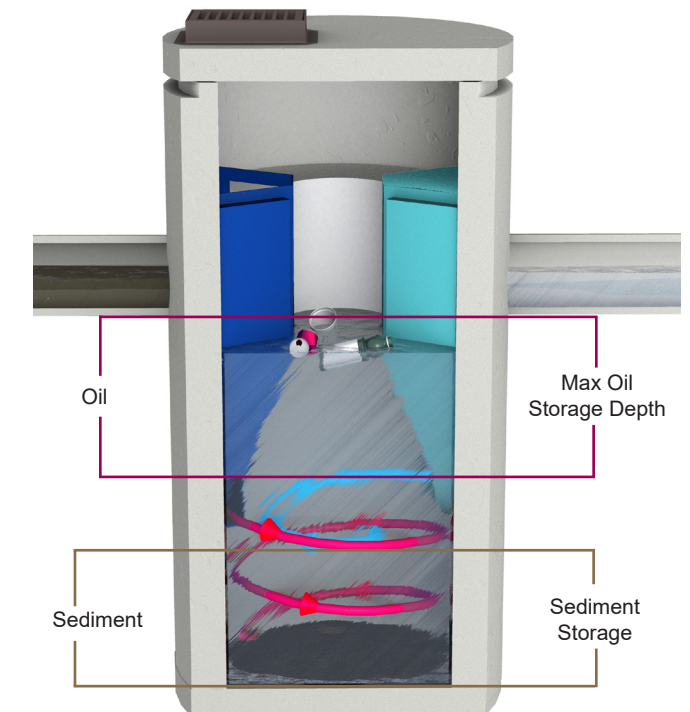
Fig.1 Pollutant storage volumes in the First Defense®.

The internal components of the First Defense® have been designed to optimize pollutant capture. Sediment is captured and retained in the base of the unit, while oil and floatables are stored on the water surface in the inner volume (Fig.1).

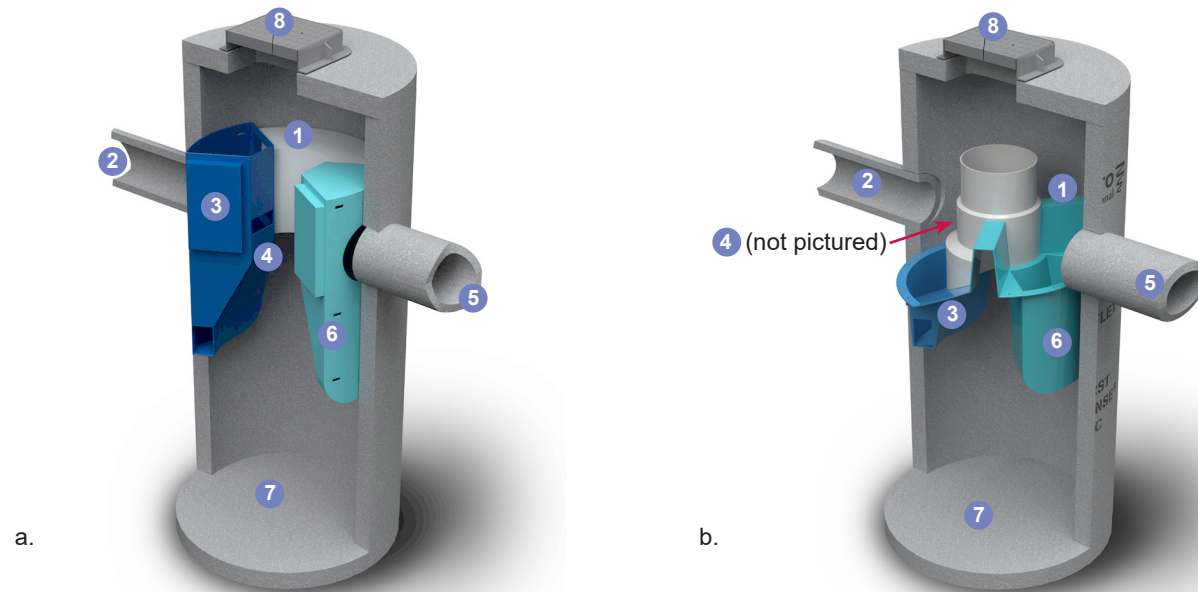
First Defense® Components

- 1. Built-In Bypass
- 2. Inlet Pipe
- 3. Inlet Chute
- 4. Floatables Draw-off Port
- 5. Outlet Pipe
- 6. Floatables Storage
- 7. Sediment Storage
- 8. Inlet Grate or Cover

Fig.2a) First Defense®-4 and First Defense®-6; b) First Defense®-4HC and First Defense®-6HC, with higher capacity dual internal bypass and larger maximum pipe diameter.

All First Defense® models include the internal components that are designed to remove and retain total suspended solids (TSS), gross solids, floatable trash and hydrocarbons (Fig.2a - 2b). First Defense® model parameters and design criteria are shown in Table 1.

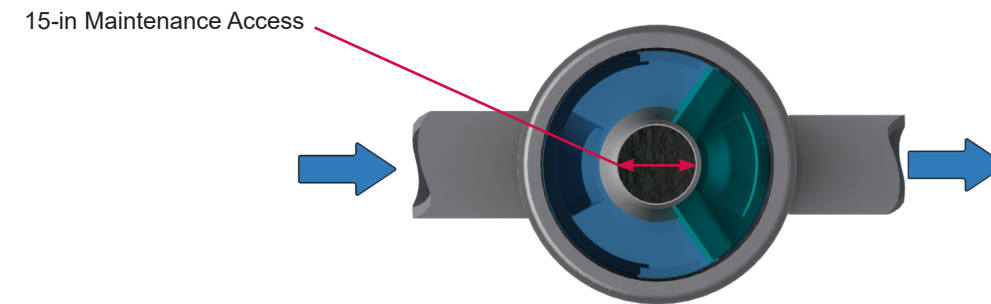
Fig.3 The central opening to the sump of the First Defense®-HC is 15 inches in diameter.

The internal components of the First Defense®-HC have a centrally located circular shaft through which the sediment storage sump can be accessed with a sump vac hose. The open diameter of this access shaft is 15 inches in diameter (Fig.3). Therefore, the nozzle fitting of any vactor hose used for maintenance should be less than 15 inches in diameter.

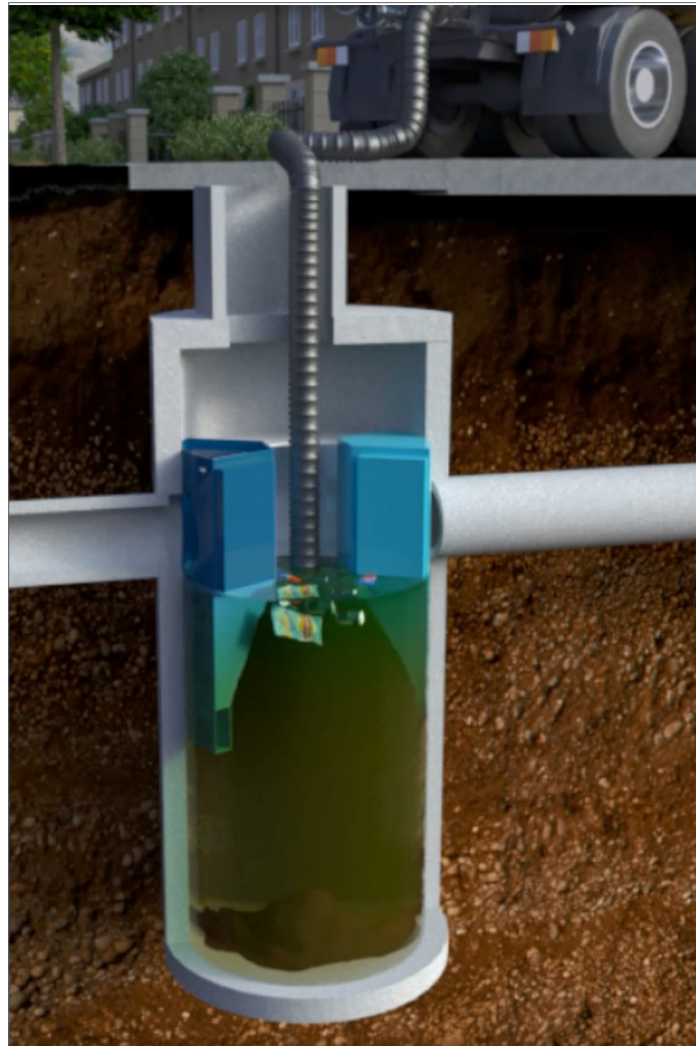
Fig.4 Floatables are removed with a vactor hose (First Defense model FD-4, shown).

2. Remove the grate or lid to the manhole.
3. Without entering the vessel, look down into the chamber to inspect the inside. Make note of any irregularities. Fig.4 shows the standing water level that should be observed.

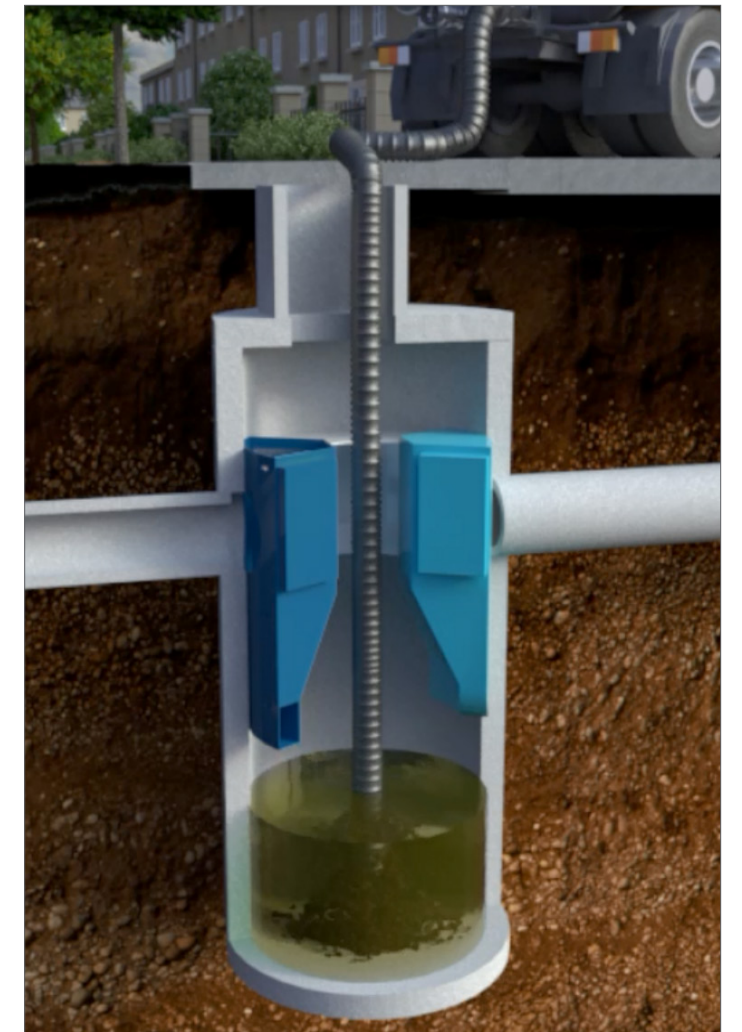
Fig.5 Sediment is removed with a vactor hose (First Defense model FD-4, shown).

Floatables clean out is typically done in conjunction with sediment removal. A commercially or municipally owned sump-vac is used to remove captured sediment and floatables (Fig.5).

4. Remove oil and floatables stored on the surface of the water with the vactor hose (Fig.5) or with the skimmer or net (not pictured).
5. Using a sediment probe such as a Sludge Judge®, measure the depth of sediment that has collected in the sump of the vessel and record it in the Maintenance Log (page 9).

6. Once all floatables have been removed, drop the vactor hose to the base of the sump. Vactor out the sediment and gross debris off the sump floor (Fig.5).
